Clean Air Act Compliance Inspection Report

Clean Air Act Partial Compliance Evaluation Inspection Report

**Gas Transmission Northwest LLC
Grass Valley, Oregon
Madras, Oregon
Bend, Oregon**

Inspection Dates: July 19-20, 2022

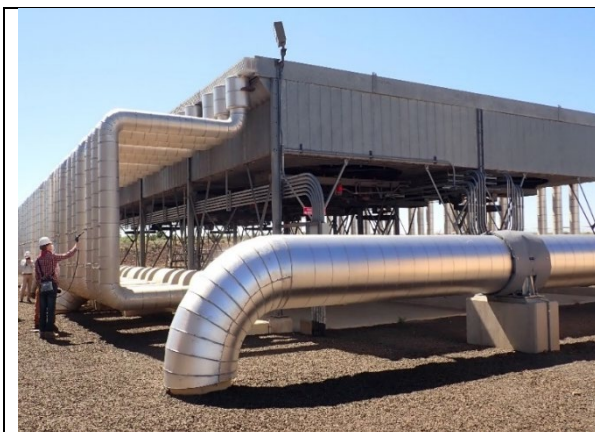
Gas Cooler. Natural gas coming through the facility becomes heated when it is compressed. Before leaving the facility, gas is cycled through a cooling system which resembles a large radiator cooled with roof fans. See Figure 1, below. 11 vapor leaks were found on components of the Gas Cooler system using Method 21. The leaks were found coming from valves installed in vertical pipe runs of the cooling system. See Figure 2, below. VOC concentrations measured by the TVA 2020 ranged from 2,000 – 50,000 ppm. At one or more locations the TVA 2020 “flamed out” while getting a reading. “Flame out” also occurred at times while monitoring other locations at Compressor Station 10 that day. The first seven leaks were not visible while using OGI by either EPA Inspector Pavitt or Montrose contractors. Bright sunshine reflecting off of the shiny metallic surface of the cooling pipes made viewing more difficult. It is the understanding of the EPA inspectors that after they departed at the end of the day, Montrose re-monitored the leaking components which EPA had discovered using Method 21 at the Gas Cooler and that Montrose confirmed the vapor leaks. The last four leaks, on the shaded side of the gas cooler, were found by Montrose using OGI. The four leaks were found to be coming from threaded connectors underneath insulation.

Figure 1: Gas Cooler System. EPA Inspector Heins (foreground) checking for fugitive emissions using a TVA 2020 instrument (Method 21), while EPA Inspector Pavitt (background) uses a FLIR Camera (OGI).

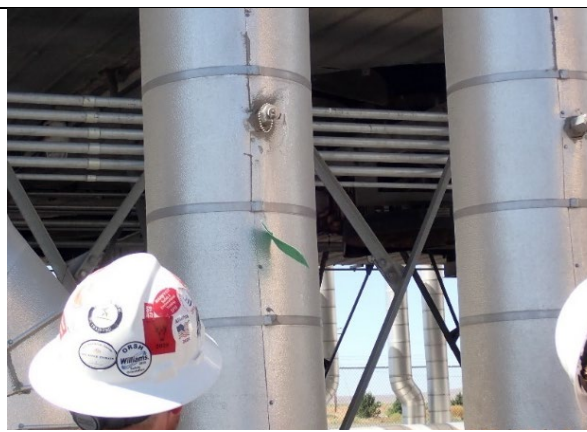
Figure 2: Example of leaking valve on the Gas Cooler found using Method 21. A tag was applied to the location by Montrose. All 11 leaks from the Gas Cooler were repaired by 8/9/22 according to facility records. (See Attachment 5-D, 7/19/2022 OOOOa Survey Details.)

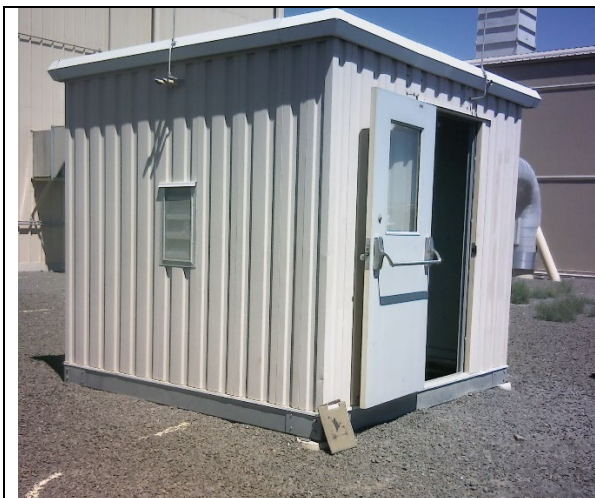
Figure 3: Shelter for Valve 65 B (B-Line Blowdown Valve). One of multiple shelters that are part of the facility's monitoring plan for undergoing quarterly Leak Detection and Repair (LDAR).

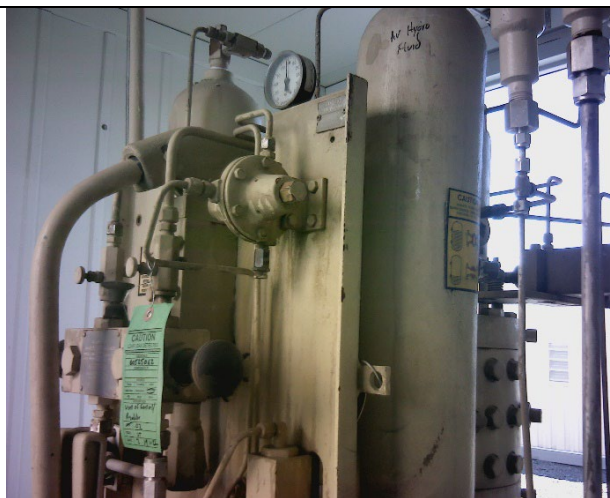
Valve Shelters. Compressor station valves are housed in sheds for weather protection. Before stepping inside the shelters, Site Operator Dainty and EPA Inspector Heins measured ambient VOC levels, which was elevated in some locations. EPA inspectors waited with doors open for the air to ventilate briefly before entering. See Figures 1 and 2, below. At some shelters, we found leaks from components inside the shelters and also from pressure relief valves connected to them and venting outdoors.

Figure 4: Inside Valve 65 B Shelter. A leak was found on this valve regulator. Montrose tagged the leaking component upon discovery. Tag No. 60525062. Source: Open-Ended Line. This leak was repaired on 8/9/22 according to facility records. (See Attachment 4-D, 7/19/2022 OOOOa Survey Details.)
